# HUMAN FACTORS NEWS

Issue 17

November 2017

## THEME — AWARENESS

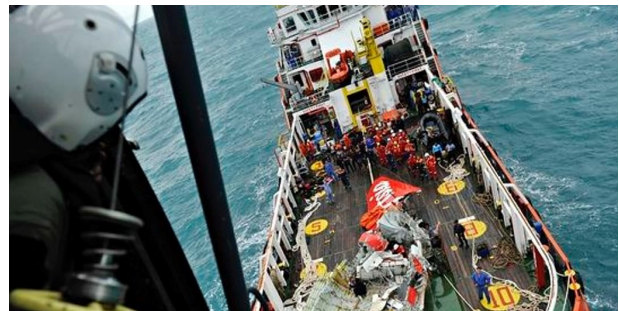
A tiny soldered electrical connection in the aircraft's rudder travel limiter unit (RTLU) was found to be cracked, likely for more than a year, causing it to intermittently send amber master caution warnings to the ECAM. The aircraft's maintenance records showed that the RTLU warning had been triggered 23 times over the previous year, but was always solved by resetting the RTLU system.

On the fourth occurrence of the RTLU warning during the flight, the Captain chose to ignore the procedure advised by the ECAM instructions and, instead, left his seat and reset the circuit breaker of the entire FAC, unintentionally disengaging multiple flight control systems, which needed to be turned on again by the pilots after the circuit breakers were reset. This circuit breaker is not on the list of circuit breakers that are allowed to be reset in flight, and disabling both FAC computers placed the aircraft in alternate law mode,

disengaging the autopilot and stopping the automatic stall protection.

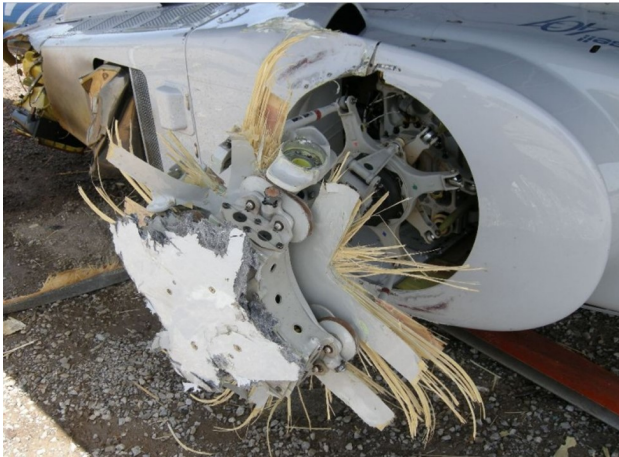
On 11<sup>th</sup> July 2016, a Bell 407 helicopter crashed on approach to a landing site in Tennessee. A witness reported that at approximately 75 to 100 feet above the ground the main rotor tilted to the right. Immediately afterwards, the helicopter banked to its right and fell to the ground on its right side. The pilot was killed in the impact.

Initial examination of the wreckage revealed that the collective lever, which connected the cockpit collective controls to the main rotor, was disconnected from the pivot sleeve. The safety wire securing the screws to the pins was missing. The screws had backed out over time, resulting in the complete loss of collective control in flight.

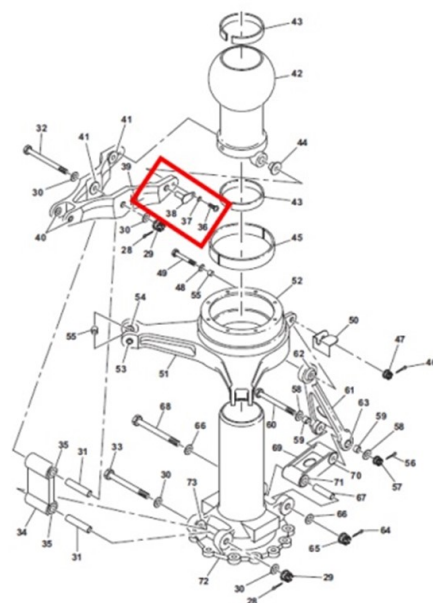
An inspection of the condition of the flight control bolts and nuts was one of the maintenance tasks carried out shortly before the accident, but an inspection of the collective lever pins, screws, and corresponding lockwires was not included in that inspection.

Figure 1 - Swashplate support assembly, with collective pitch lever attaching hardware outlined in red.
